# Corduff Handball Alley Renovation

Handball  
Renovation  
2018

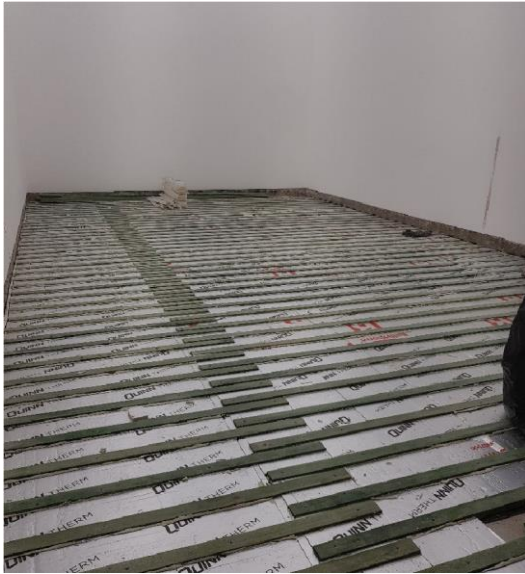
Allow for 150mm of insulation under the finished floor when building a new alley. If you are renovating your alley and there is little or no insulation in the floor, then you can install 25mm insulation between the battens as per picture below.

Fig 1.0 – Installation of  
25mm Floor  
Insulation

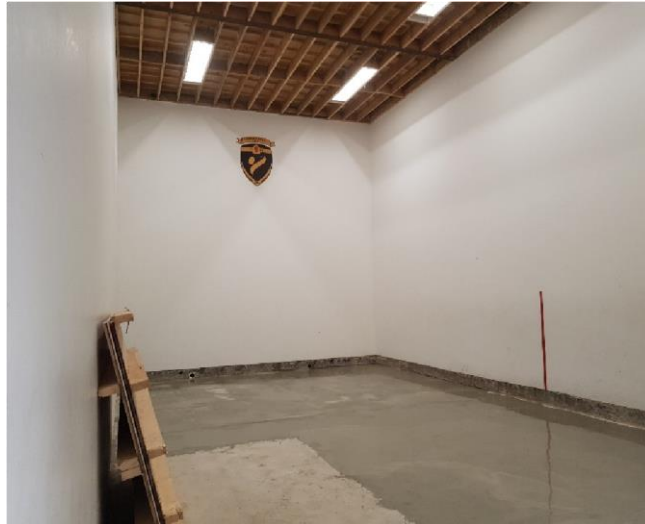
It is very important to ensure the finished floor is level to make it easier to install the timber battens. Self---levelling compound was poured on the floor before the battens were installed. Once the self---levelling compound was set we painted concrete sealer on the floor to prevent any moisture rising up through the concrete.

Fig 2.0 – Pouring of Self Levelling Compound

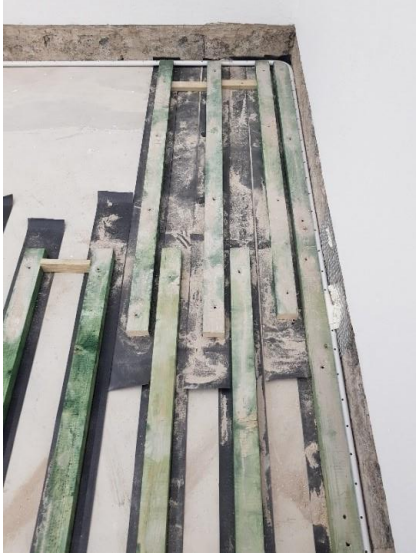
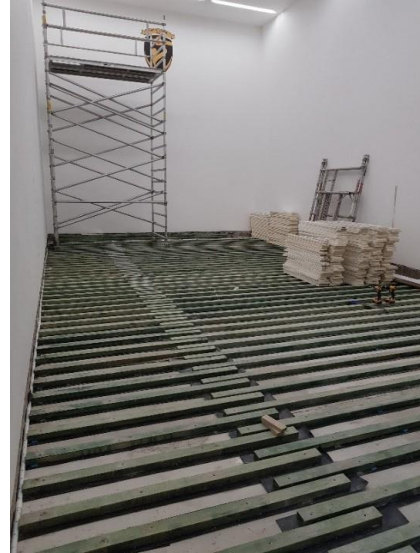
3"\*2" battens were installed at 250mm centres. We installed the battens this distance apart to ensure a consistent bounce of the ball on the floor and also to keep maximum speed of the ball. DPC was placed under each batten to stop it rotting over time. A 20mm gap was left between the battens at the overlap to allow air to easily flow under the floor. Each batten is also treated with timber preservative.

Fig 3.0 and 4.0 – 3"\*2" Batten installation

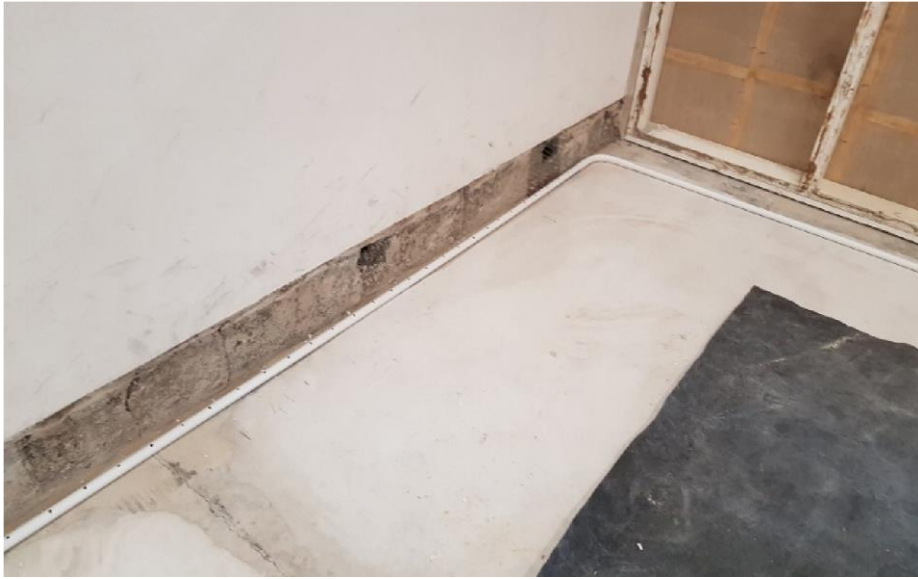
Air flow under the floor is extremely important to prevent the timber rotting over time. Under the old raised floor there was 4 vents to bring in fresh air. The original floor was 9" off the ground and therefore the vents allowed the air to pass under the floor easily. We decided to install 25mm plastic conduit around the perimeter of the alley, the conduit has a 8mm hole drilled every 4". The conduit was then teed into the existing wall vents. The conduit allows air to flow around the alley and between the battens. When the ventilation system is installed this would increase the flow of air under the floor.

Fig 5.0 – Installation of 25mm Plastic Conduit

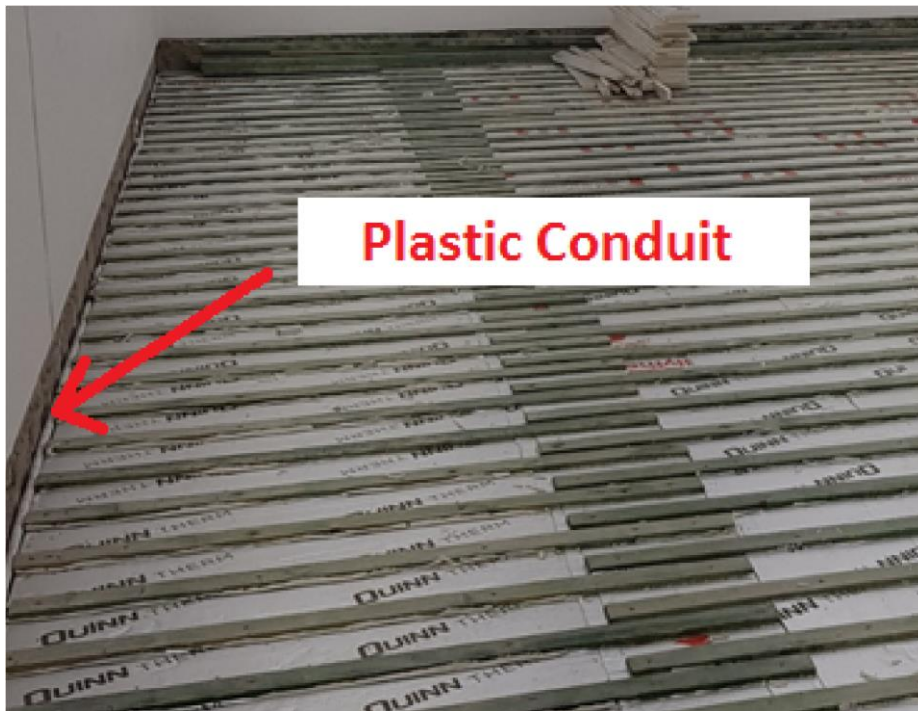
Fig 6.0 – Plastic conduit around perimeter of alley

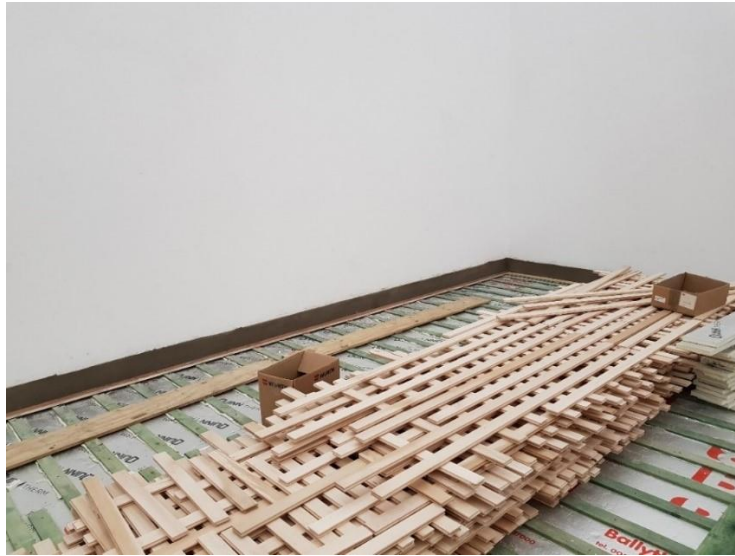
Before installing the floor, we took the timber out of the cardboard boxes and spread out in the alley as per picture below. We stacked the timber on top of each other allowing the air to flow between each piece. The floor was left in the alley for 3

weeks before it was installed. This is to allow the wood to settle in the new environment and moisture levels in the floor to level out. Some boards may twist or warp during this time which should be thrown away.

Fig 8.0 – Ventilation of Maple Timber

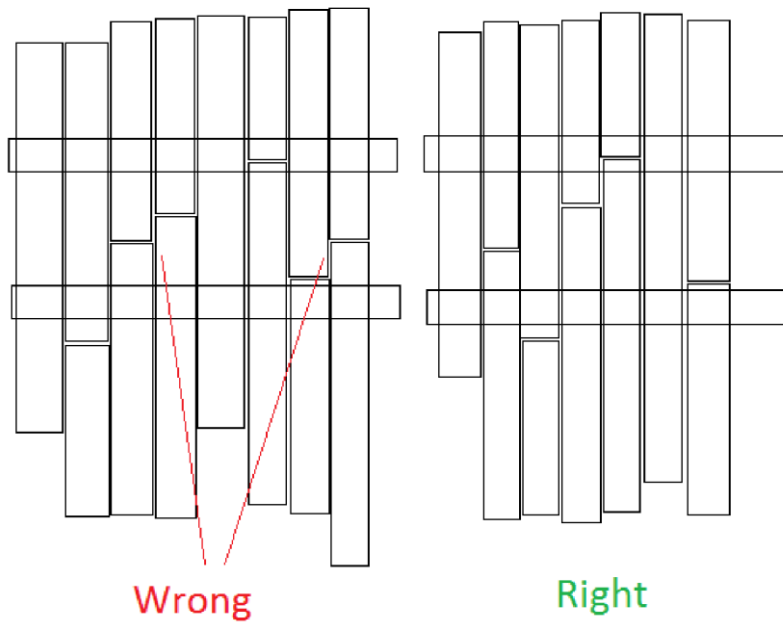
Fig 10.0 – Right and Wrong way to install Maple floor.

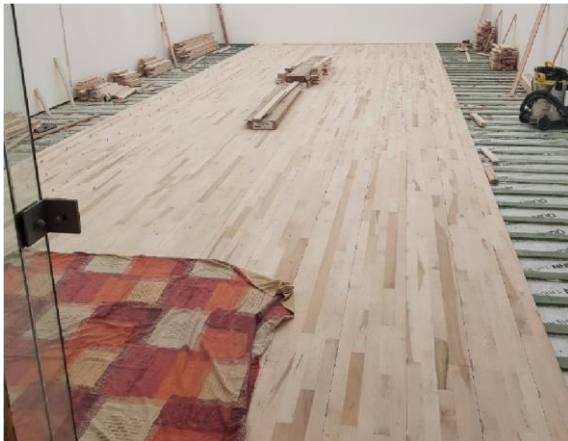
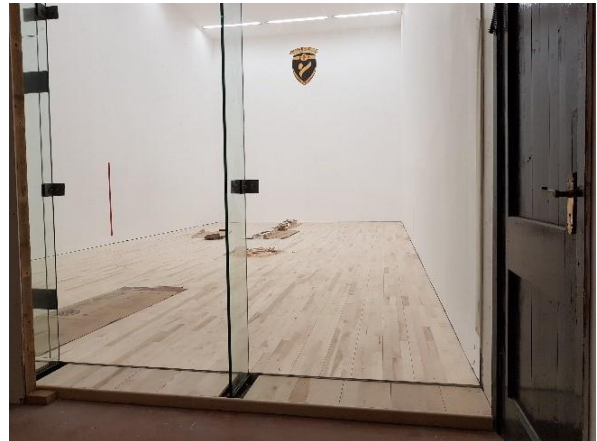
Fig Maple	11.0 Floor	Installation of
floor	Fig	12.0	Finished

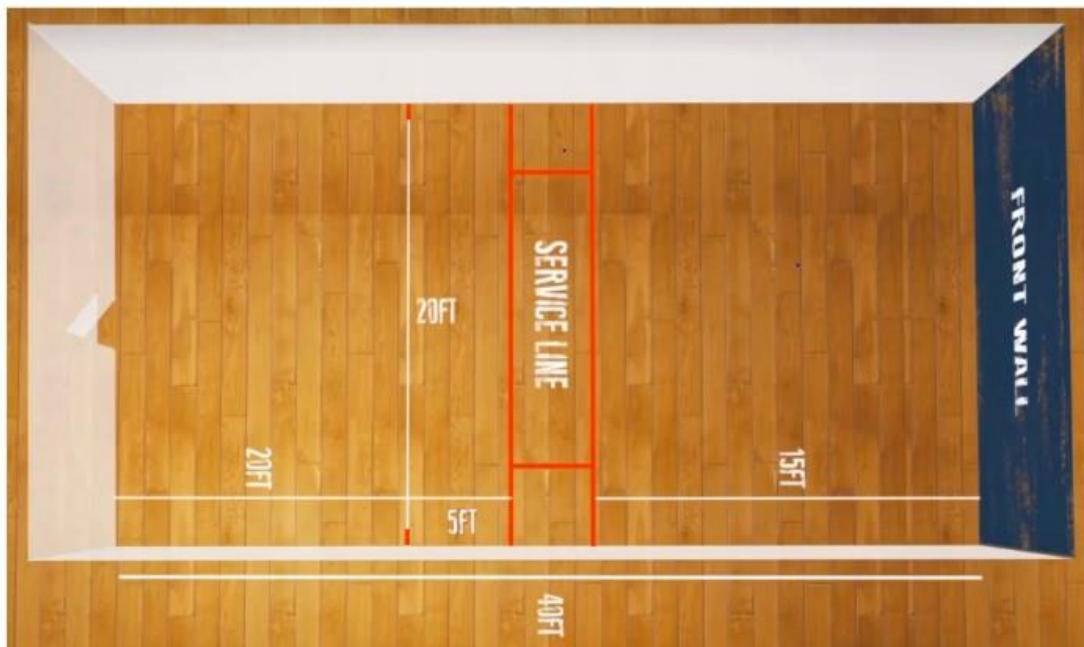
## Fig 13.0 Court Dimensions

1) **International 40x20 Court:** The dimensions are:

**Front Wall** 20ft wide, 20ft high.

**Floor** 20ft wide and 40ft long with back wall recommended minimum height of 12ft.

*(Diagram 1: 40x20 Court Dimensions)*

The timber floor is firstly sanded to ensure the surface is smooth and clear of any blemishes. GP Base coat from Gran Wax is then applied. The floor is lightly sanded again before applying a coat of Master Finish sport from Gran Wax. Floor is sanded again before applying Red games lines paint as per dimensions highlighted in Fig 13.0.

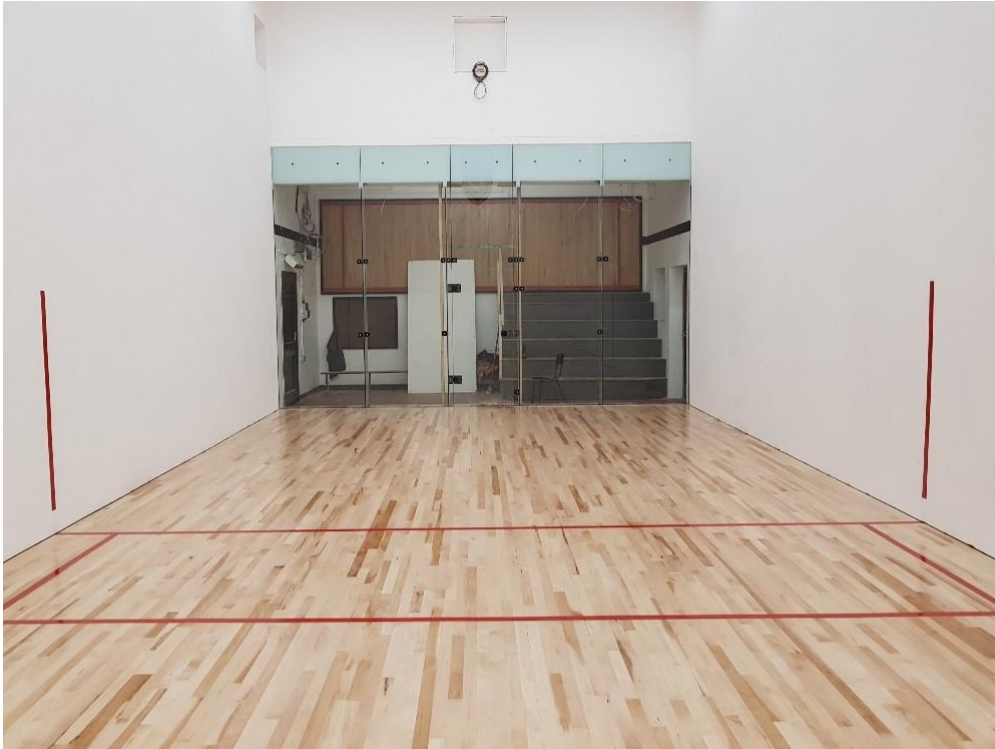
Handball courts shall be divided and marked on the floors with 2-inch wide lines. Recommended colours are white or red. The lines shall be marked as follows:

- 1) **Short line.** The short line is parallel to the front and back walls. Its outside edge is 20 feet from the front wall in the 40x20 court, and 32.5 feet from the front wall in the 60x30 court.

- 2) **Service line.** The service line is parallel to the short line and its outside edge is 5 feet in front of the outside edge of the short line.
- 3) **Service zone.** The service zone is the area between the outer edges of the short and service lines.

- 4) **Service boxes.** A service box is located at each end of the service zone by lines which have outside measurements of 18 inches from, and parallel to, each side wall.

Fig 14.0 – Serving lines painted on floor

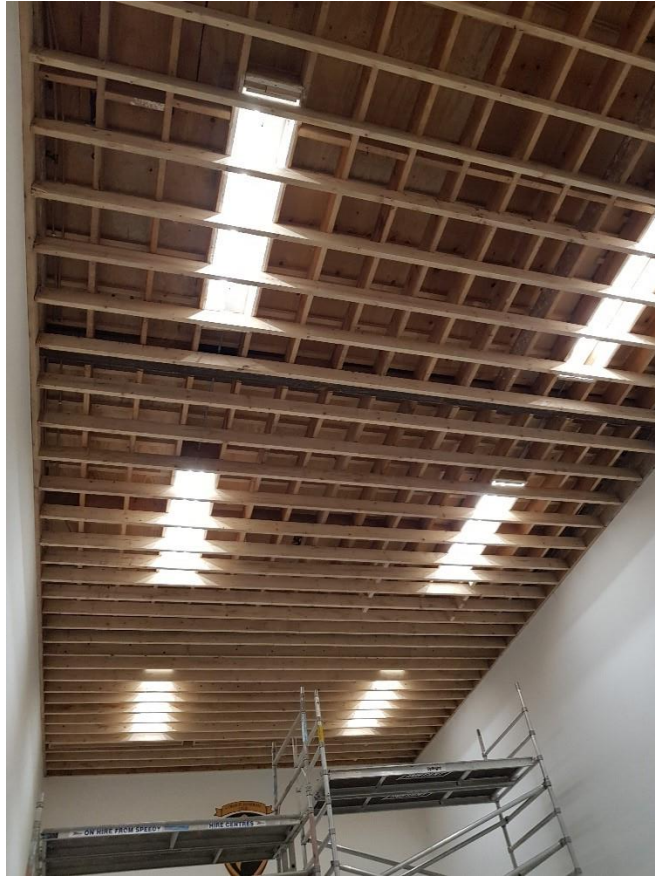
We dropped our floor and ceiling down 7" when renovating the alley. To install the new ceiling we installed 6"\*2" joists across the width of the alley. The joists are installed at 12" centres, this is to keep the speed in game playing when hitting roof shots. The joists are bolted to each sidewall and also braced to the old joists above to ensure no movement.

Fig 15.0 – Installation for Ceiling Joists

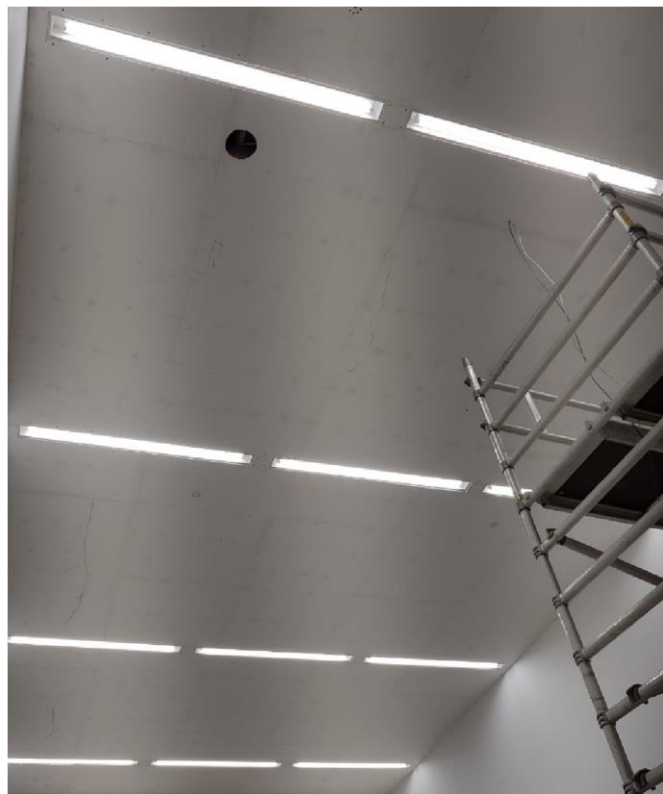
Fig 20.0 Installing Beech Plywood Ceiling

Plywood sheets are screwed to joists to secure. All Joints and the screw holes are filled with filler before ceiling receives second coat of paint. Polycarbonate clear sheets are screwed to the bottom of each light box to protect lights during game play.

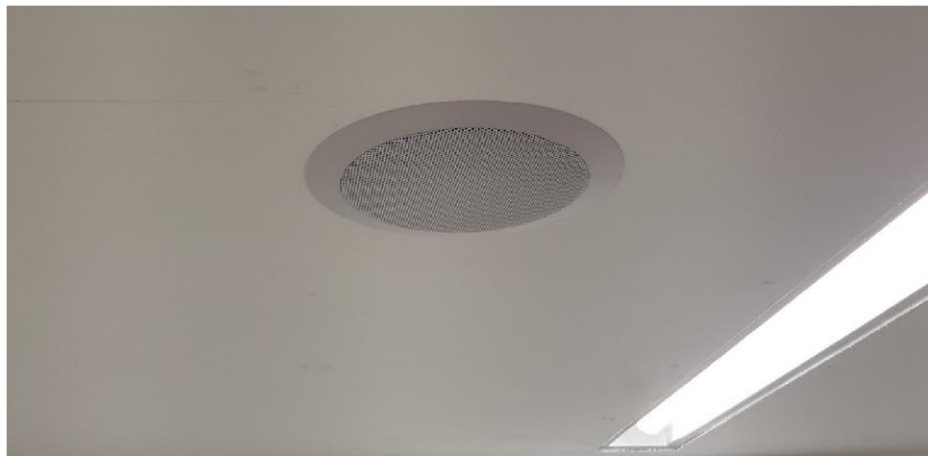
Fig  
Speaker

installation

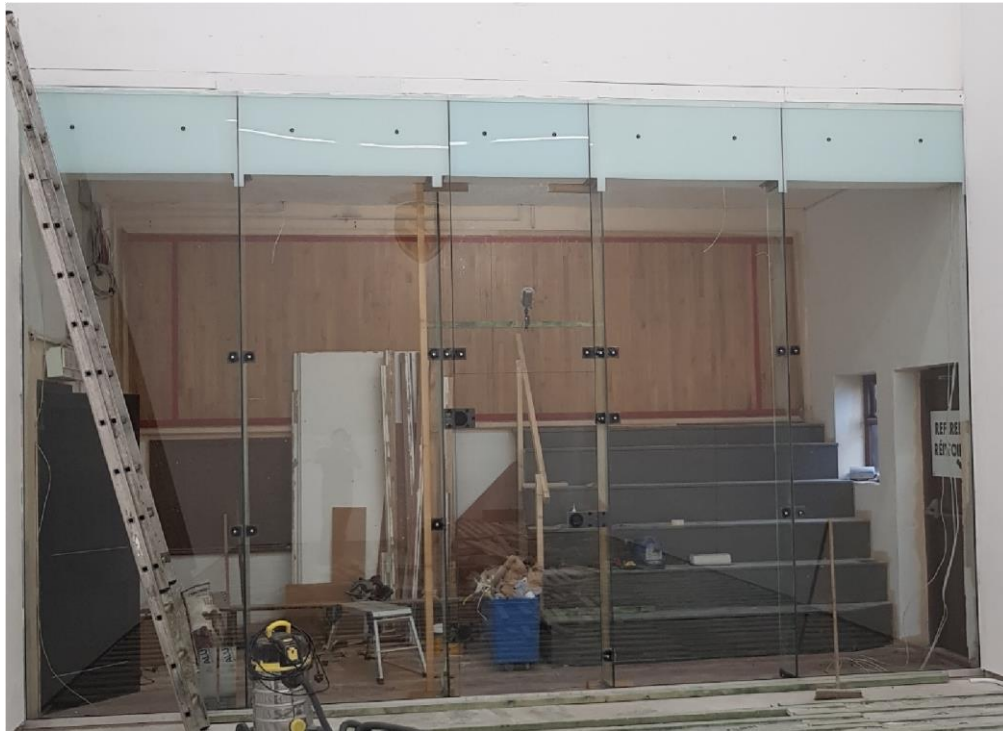
Fig 24.0 – Glass wall Installed
